BRAZOSPORT INDEPENDENT SCHOOL DISTRICT

Long Range Facilities Planning Committee
2014 Bond Program
Meeting #4

May 14, 2014

FACILITY CONDITION ASSESSMENT

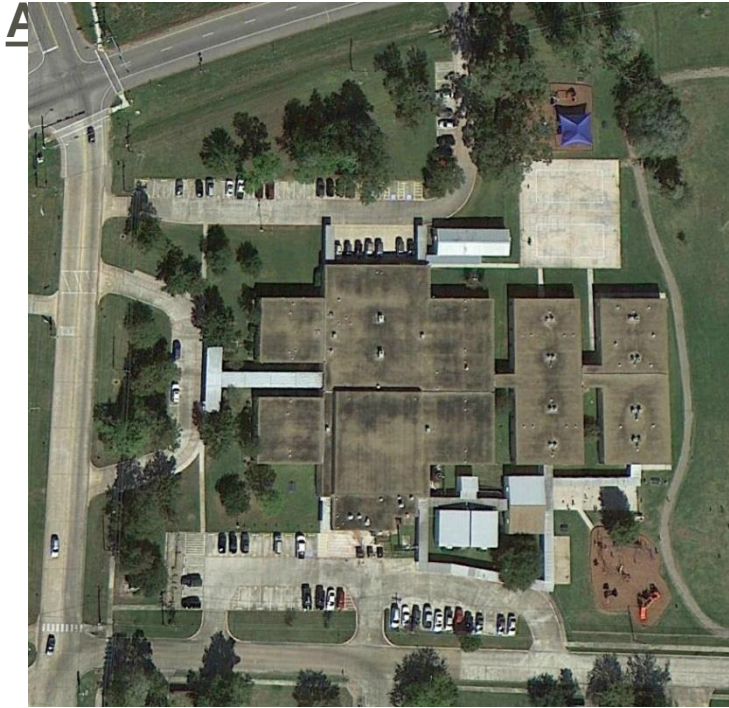
BESS BRANNEN ELEMENTARY SCHOOL

Overall Score : 3.76

Mechanical; Replace Cooling Tower, RTUs

Plumbing; Replace Galvanized Piping

Security; lacks entry vestibule, exterior access to portable
Nearly half of Classrooms do not meet TEA Standards
ADA; lacks Parking at Entry Drive, Restroom, Sinks, Signage
Foodservice Equipment

Lacks Fire Sprinkler System
Electrical Power; Inadequate
Outdated, undersized Kitchen and

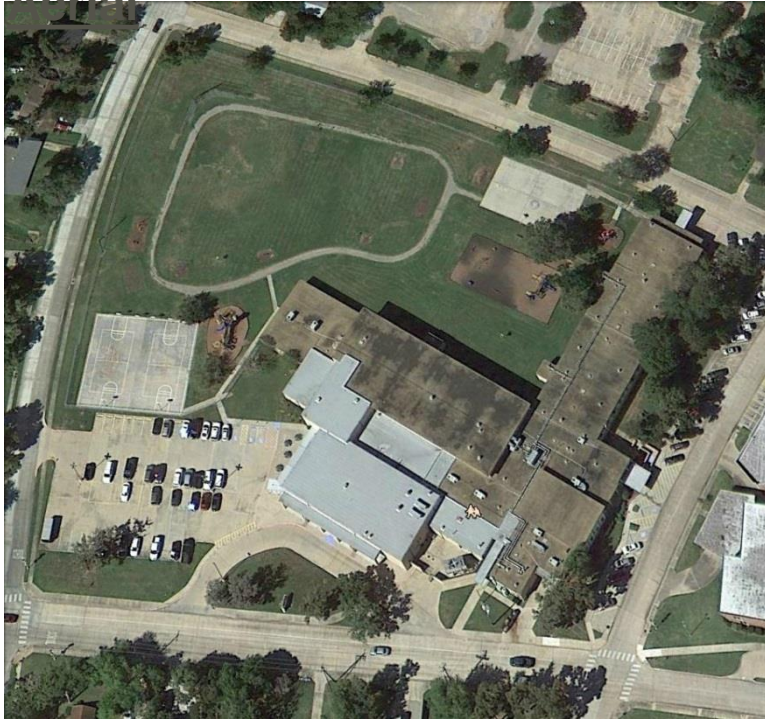
ELISABET NEY ELEMENTARY SCHOOL

Overall Score : 3.82

Exterior Walls/Windows; fair to poor condition
ADA Accessibility; restrooms, clearances
Site Drainage
building
Approx. 1/3 of Classrooms do not meet TEA minimum stds

Mechanical; replace RTUs, piping & insulation
Electrical; inadequate power/data
Plumbing; replace galvanized piping in older
Lacks Fire Sprinkler System

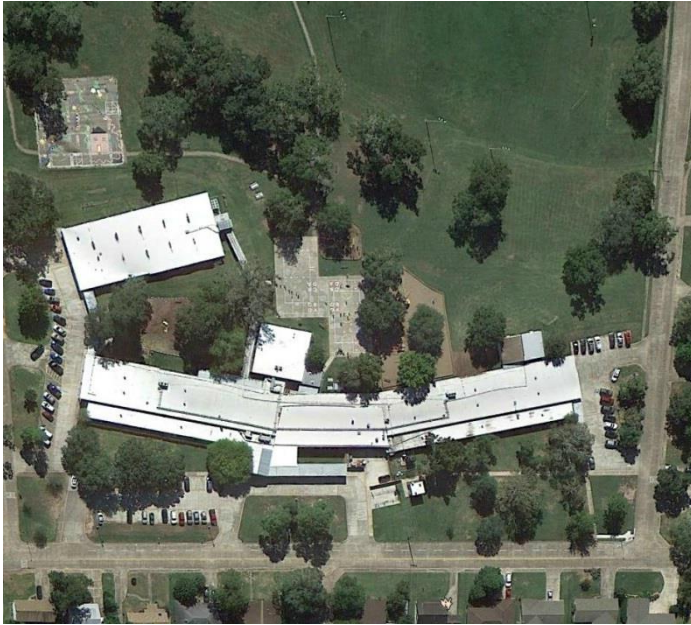
A.P. BEUTEL ELEMENTARY SCHOOL

Overall Score : 4.50

Security; lacks vestibule, fencing, secure access to outbuildings
all equipment except chiller
ADA Accessibility; restrooms, clearances, hardware

Roof (past useful life cycle)
minimum standards

Exterior walls/windows; poor condition
showing wear
Layout; separate classroom wings

Mechanical; replace

Site Drainage; swales and ponding

Most classrooms do not meet TEA

Kitchen: equipment outdated

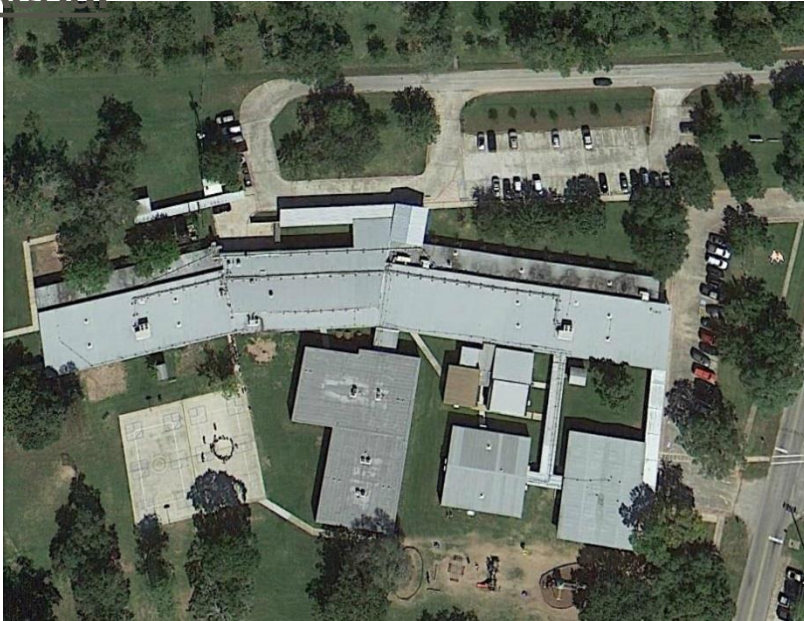
T.W. OGG ELEMENTARY SCHOOL

Overall Score : 3.74

Security; lacks vestibule, fencing, secure access to outbuildings
replace all equipment except chiller
ADA Accessibility; restrooms, clearances, hardware
ponding
Plumbing; replace galvanized piping
minimum standards

Mechanical;

Site Drainage; swales and

Most classrooms do not meet TEA

Kitchen: equipment outdated

Lacks fire sprinkler system

Exterior walls/windows; poor condition
showing wear
Layout; separate classroom wings

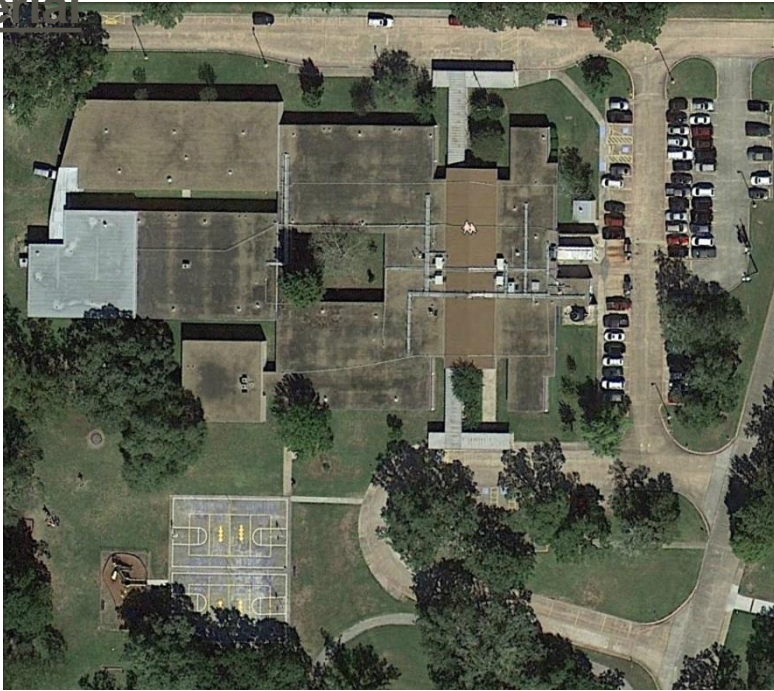
O.M. ROBERTS ELEMENTARY SCHOOL

Overall Score : 3.71

Security; lacks vestibule, fencing
ADA Accessibility; some restrooms, clearances recommended
Site Circulation & Parking minimum standards
Lacks fire sprinkler system

Mechanical; RTUs require replacement
Kitchen is undersized, full renovation
Many classrooms do not meet TEA
Electrical; inadequate power/data

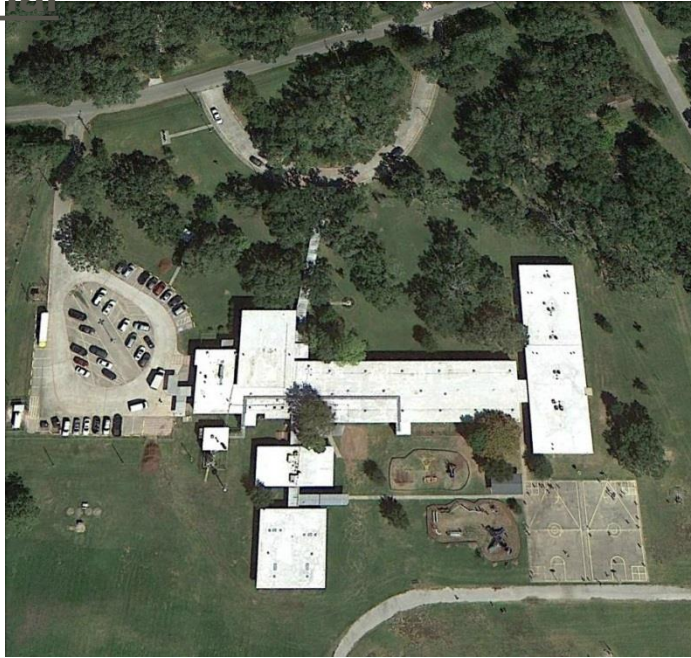
STEPHEN F. AUSTIN ELEMENTAR SCHOOL

Overall Score : 3.76

Security; lacks vestibule, secure access to outbuildings, fencing
Electrical & Plumbing Systems
ADA Accessibility; restrooms, clearances

Site Drainage

Most Classrooms do not meet TEA minimum standards

Mechanical,

Outdated kitchen facilities

Roofing requires replacement

Exterior walls/windows in poor

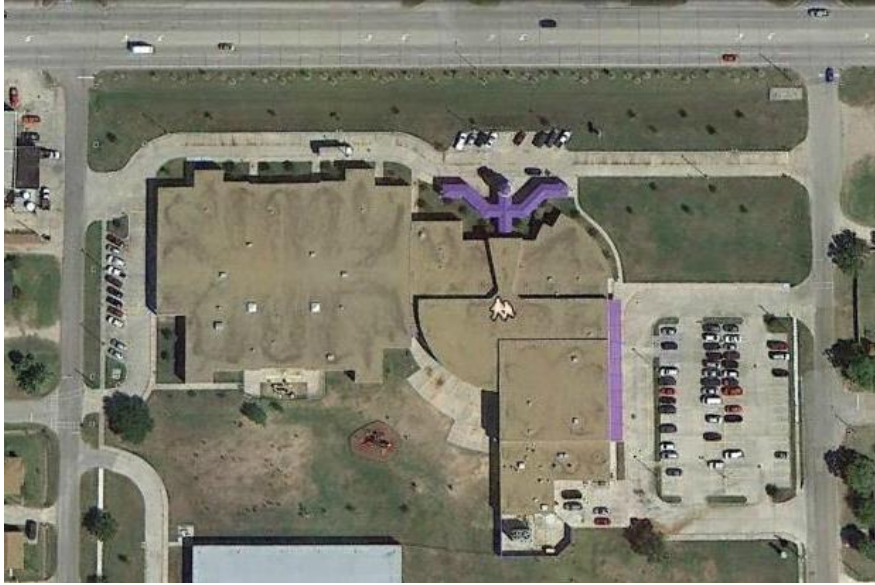
VELASCO ELEMENTARY SCHOOL

Overall Score : 2.34

Security; lacks vestibule, fencing

Mechanical; cooling tower has corrosion issues

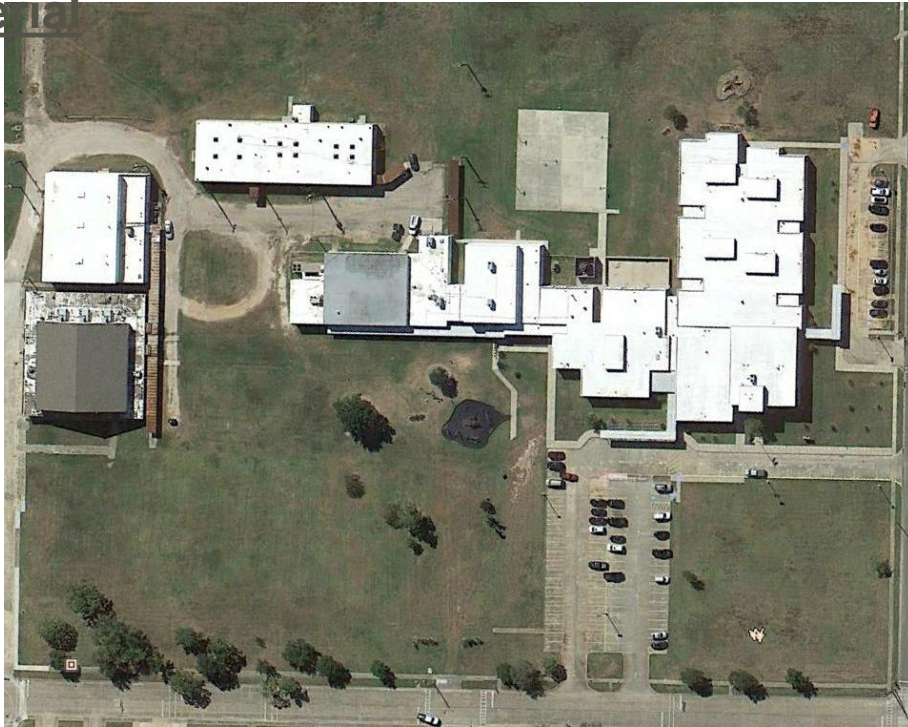
O.A. FLEMING ELEMENTARY SCHOOL

Overall Score : 3.29

Security; exterior access to Cafeteria, fencing, lacks vestibule half of AHUs

Gymnasium construction older, non ADA compliant

Some classrooms do not meet TEA minimum standards piping

Kitchen; equipment in fair/poor condition

Mechanical; Replace RTUs,

Lacks fire sprinkler system

Plumbing; replace galvanized

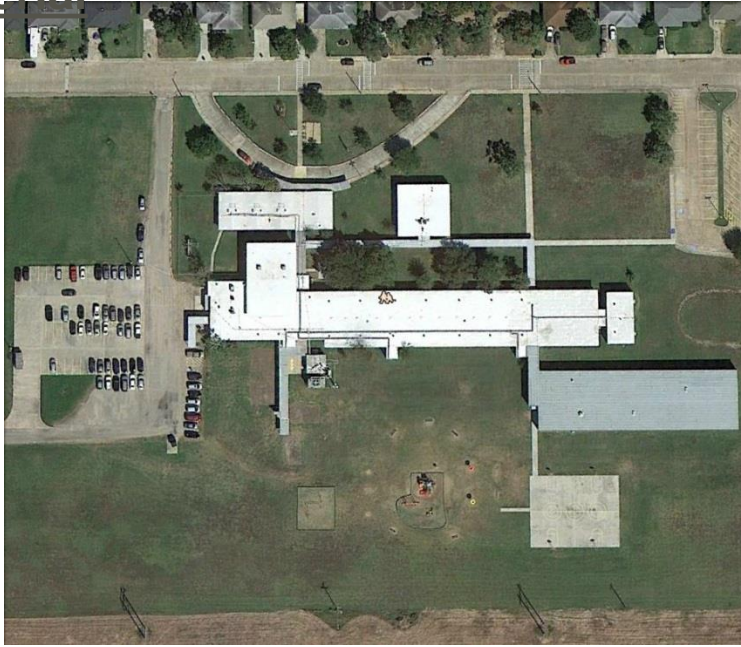
JANE LONG ELEMENTARY SCHOOL

Overall Score : 4.00

Security; lacks vestibule, fencing, exterior access to outbuildings
restrooms, clearances
Roof (leaks, past warranty)

ADA Accessibility; student

Outdated kitchen facilities

Classrooms do not meet TEA

Site Drainage
minimum standards

Kitchen; outdated equipment

Interior finishes showing age/wear

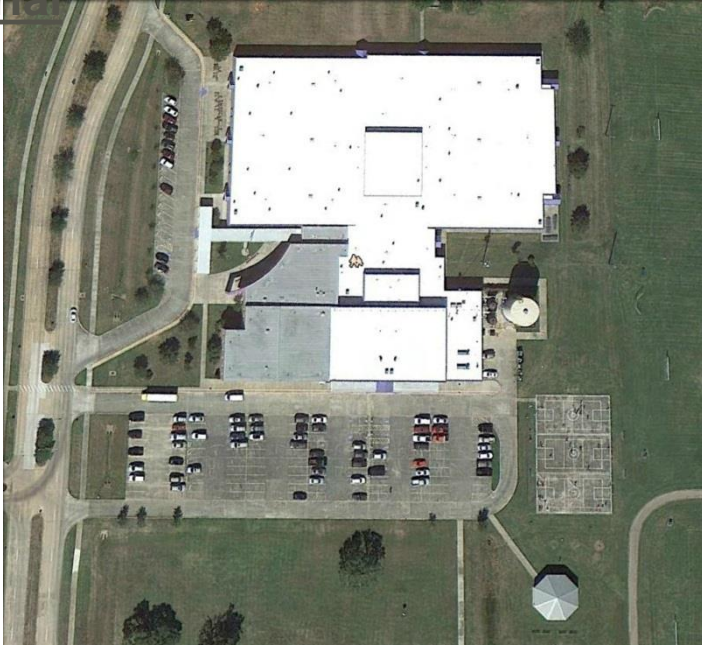
GRADY RASCO MIDDLE SCHOOL

Overall Score : 2.95

Security; lacks vestibule, fencing, multiple entries

Roof; replace single ply portion

Mechanical; replace original CP equipment

Lacks fire sprinkler system

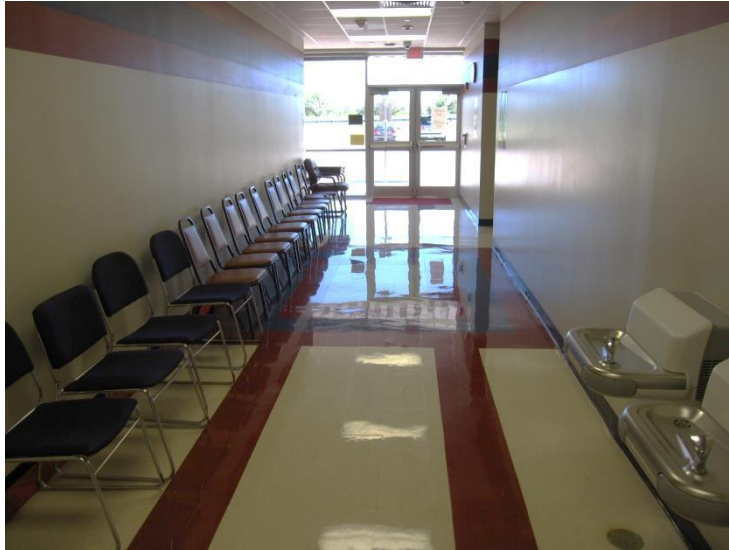
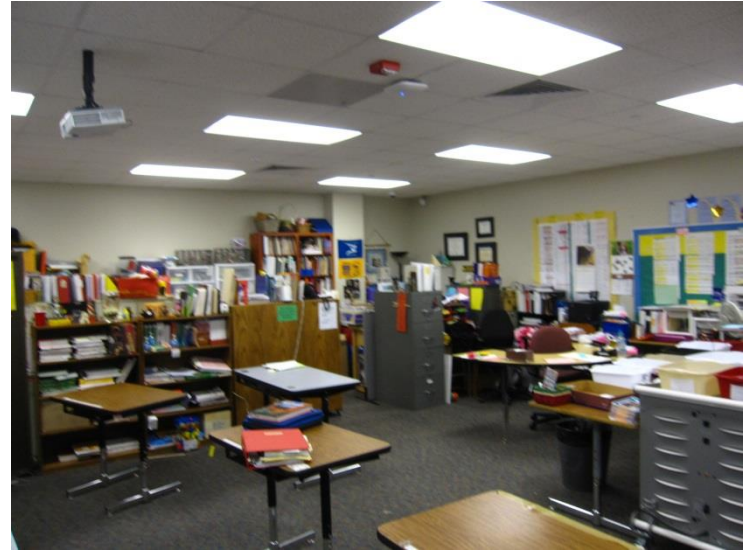
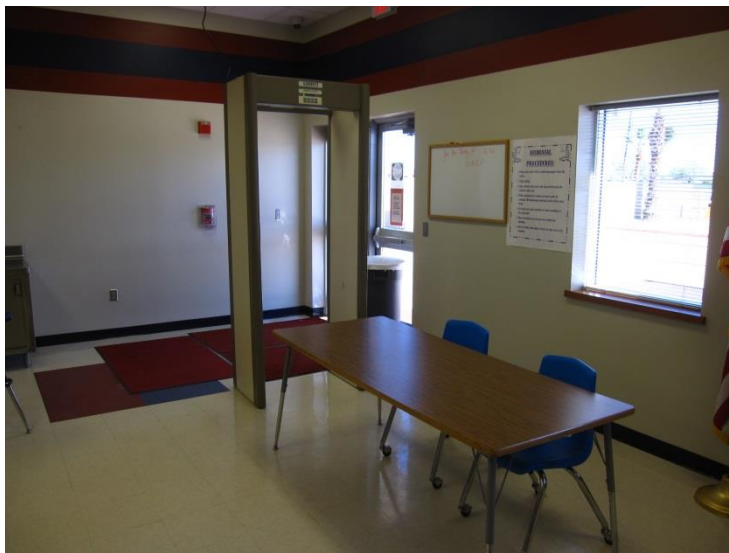
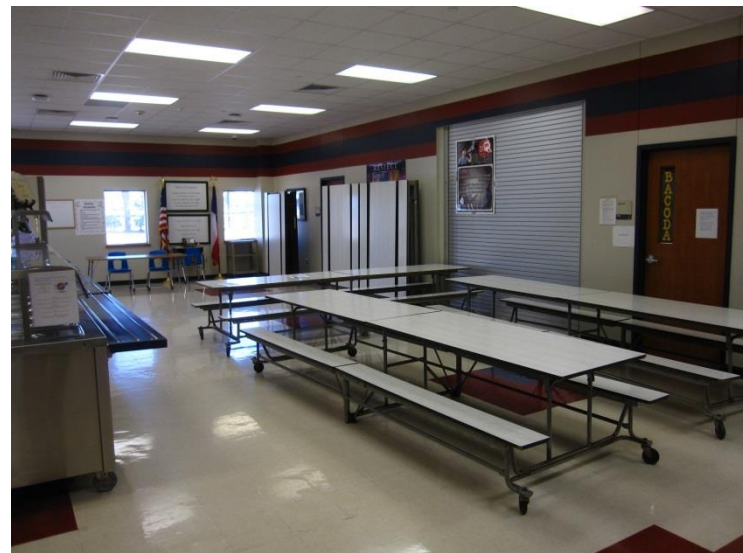
LIGHTHOUSE LEARNING CENTER

ADA Accessibility; restrooms, hardware, clearances
Mechanical; rooftop equipment replacement in near future

Interior Finishes; fair/poor condition
Lacks fire sprinkler system
