BRAZOSPORT INDEPENDENT SCHOOL DISTRICT

Long Range Facilities Planning Committee  
2014 Bond Program  
Meeting #4

May 14, 2014

# 2014 BISD FACILITY

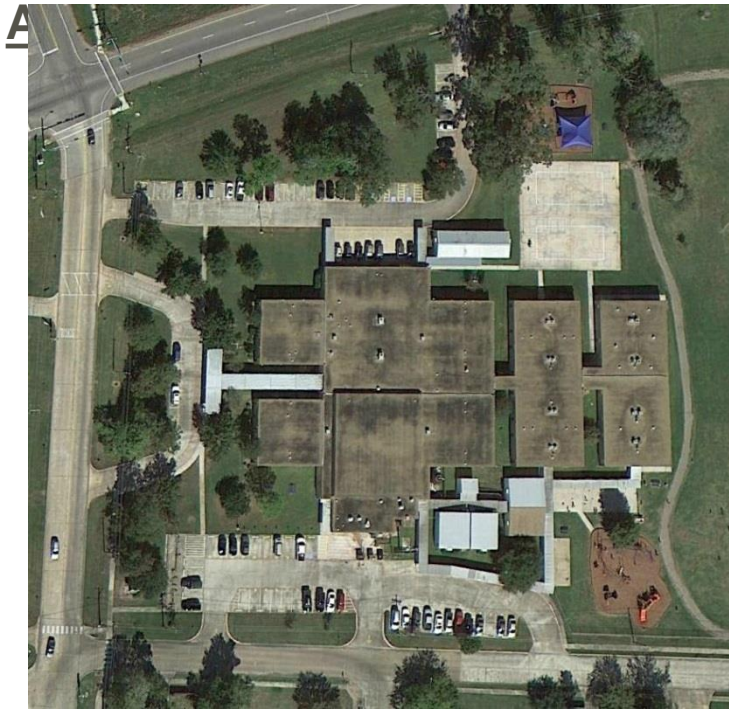
# BESS BRANNEN ELEMENTARY SCHOOL

**Overall Score : 3.76**

Mechanical; Replace Cooling Tower, RTUs

Plumbing; Replace Galvanized Piping

Security; lacks entry vestibule, exterior access to portable  
Nearly half of Classrooms do not meet TEA Standards  
ADA; lacks Parking at Entry Drive, Restroom, Sinks, Signage  
Foodservice Equipment

Lacks Fire Sprinkler System  
Electrical Power; Inadequate  
Outdated, undersized Kitchen and

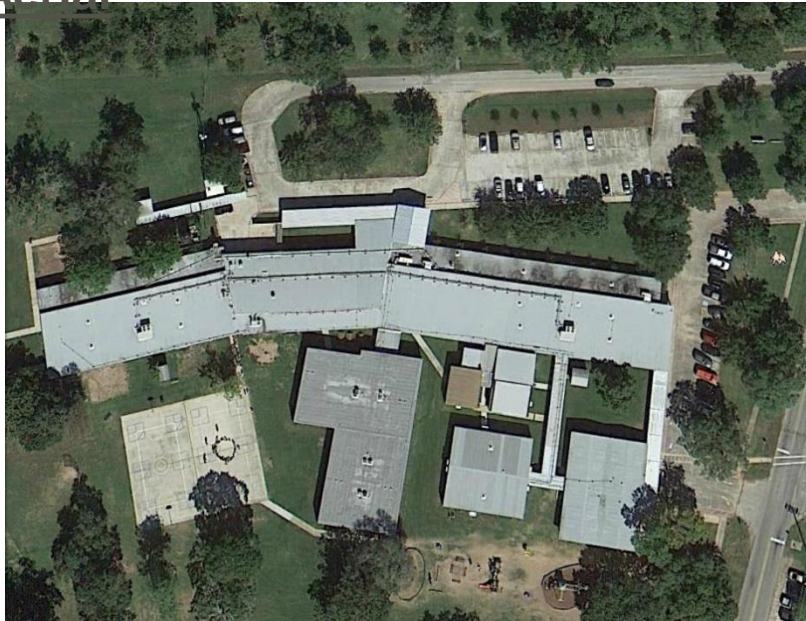
# T.W. OGG ELEMENTARY SCHOOL

Overall Score : 3.74

Security; lacks vestibule, fencing, secure access to outbuildings

ADA Accessibility; restrooms, clearances, hardware  
ponding

Plumbing; replace galvanized piping

Exterior walls/windows; poor condition

Site Drainage; swales and

Kitchen: equipment outdated

Lacks fire sprinkler system

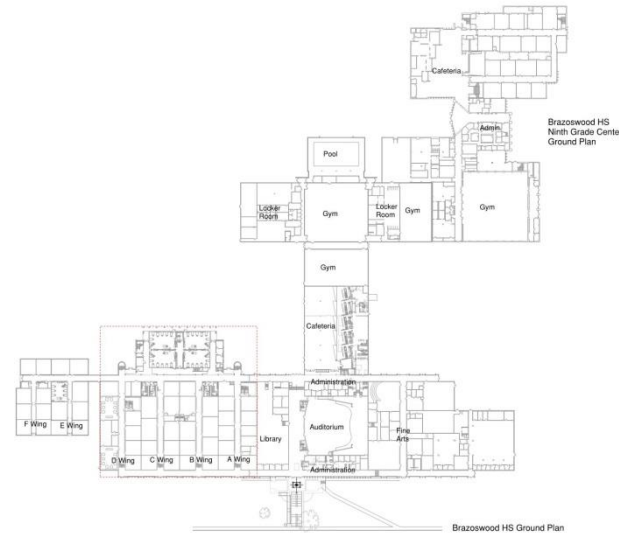
# BRAZOSWOOD HIGH SCHOOL

Overall Score : 3.29

- Security; lacks vestibule, fencing, access to outbuildings
- Roof; recommend replacement
- EMS poor condition
- Natatorium; roof structure shows signs of deterioration
- Plumbing; replace galvanized piping

- Interior finishes showing wear
- Mechanical; replace chillers @ 9<sup>th</sup> Grade,
- ADA; several areas non-compliant
- Lacks fire sprinkler system

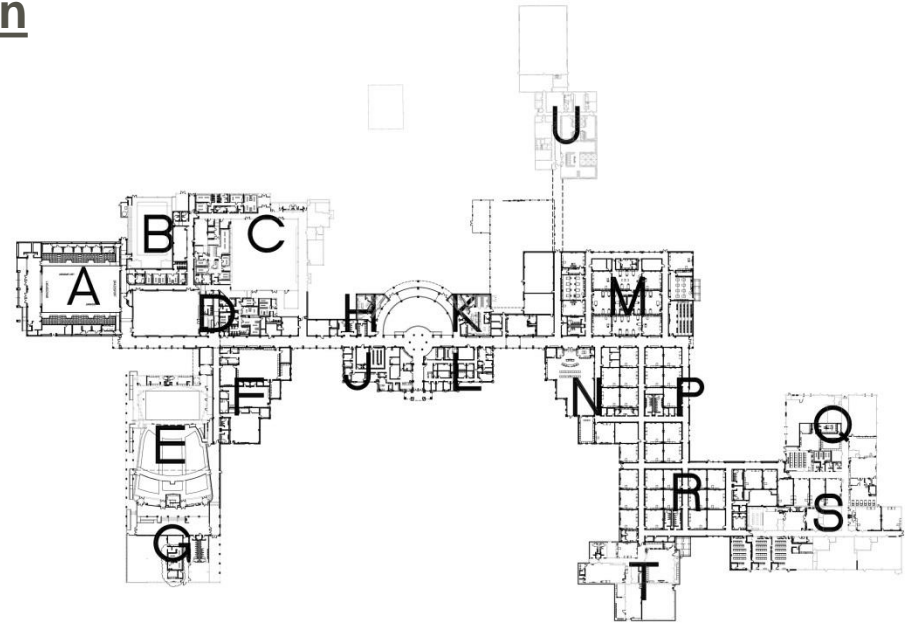
# BRAZOSPORT HIGH SCHOOL

Overall Score : 2.11

Security; lacks vestibule, fencing, access to outbuildings

ADA Accessibility; Fieldhouse

Parking; update paving @ north lot

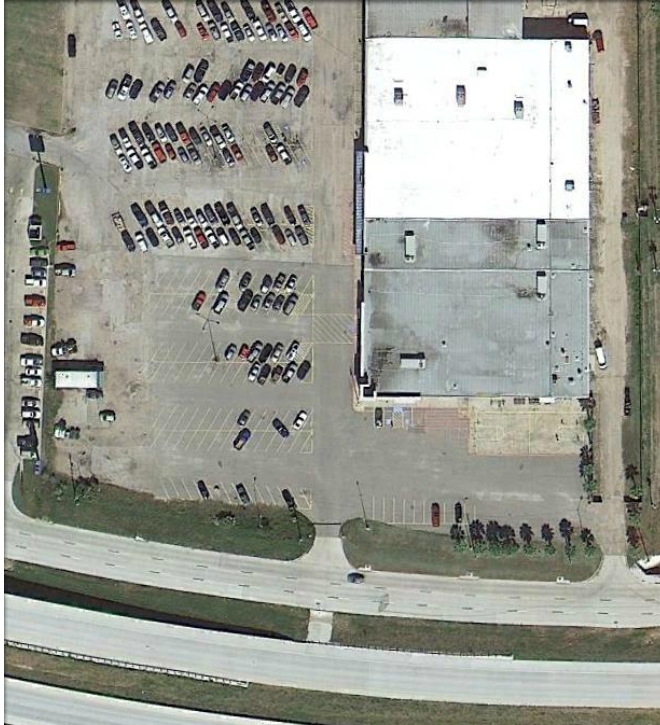
# LIGHTHOUSE LEARNING CENTER

Overall Score : 2.18

Security; lacks vestibule

Kitchen; equipment in fair/poor condition

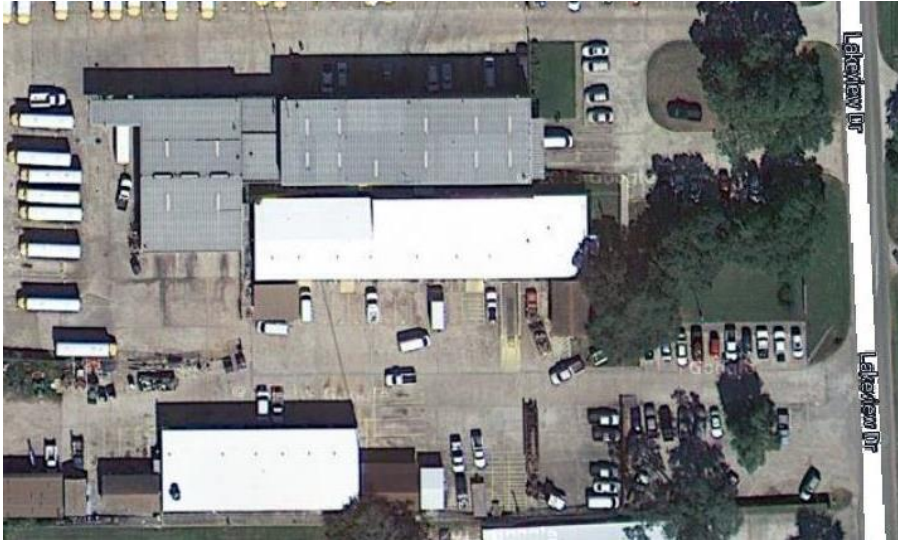
# MAINTENANCE & OPERATIONS, TRANSPORTATION, CHILD NUTRITION

Overall Score : 3.19

ADA Accessibility; parking, restrooms, clearances Interior Finishes; upgrade at office area  
Lacks fire sprinkler system
